Survey Report

☎ +357-99096385

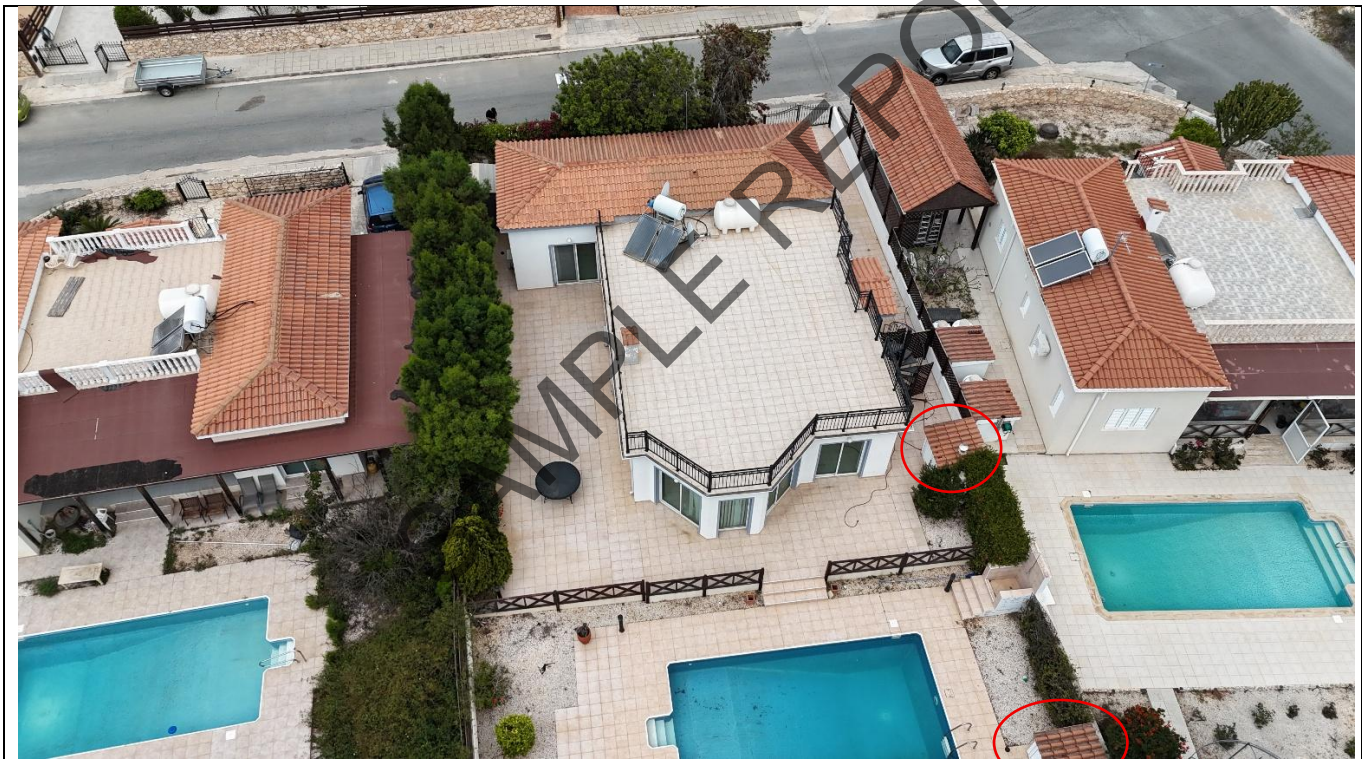
P1: The red marked areas highlight the locations of the external mechanical room/heating installations situated within the yard area of the property. These structures are positioned close to the property boundaries and are not indicated on the approved architectural drawings reviewed during the assessment.

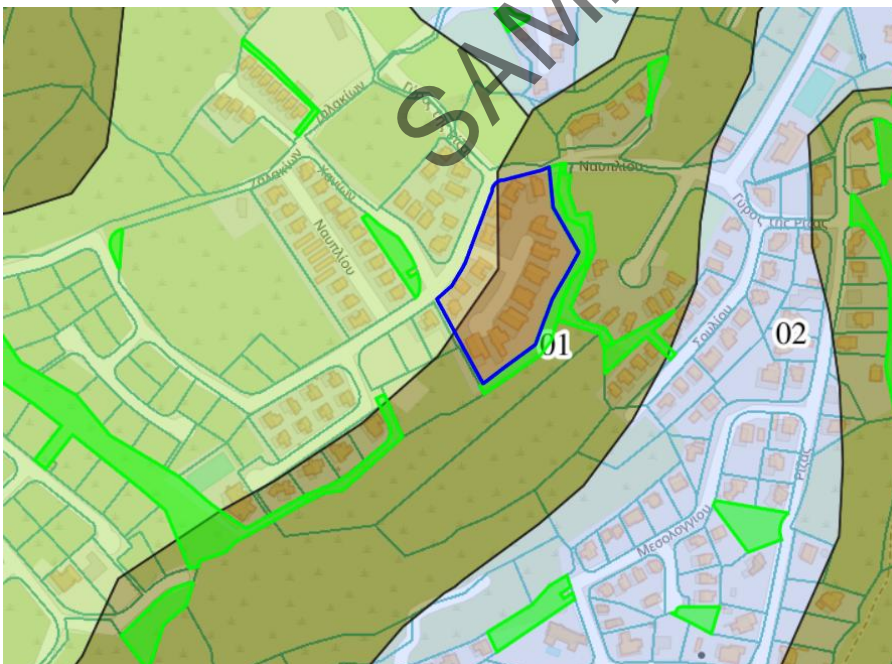
Photo 1: Geological suitability zone of the property.

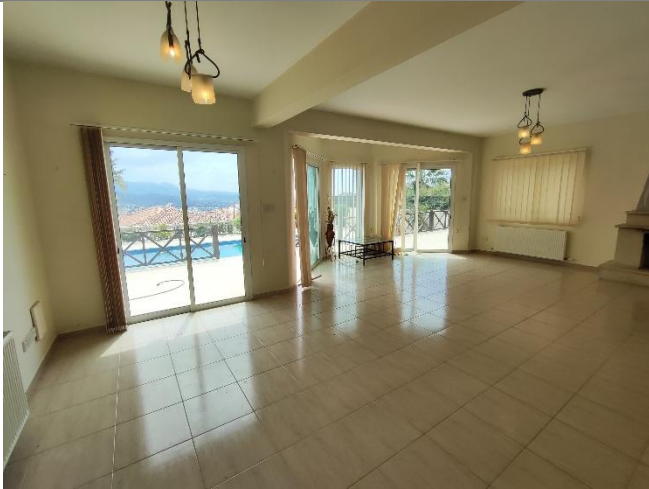
P1: Internal walls were found in sound condition.

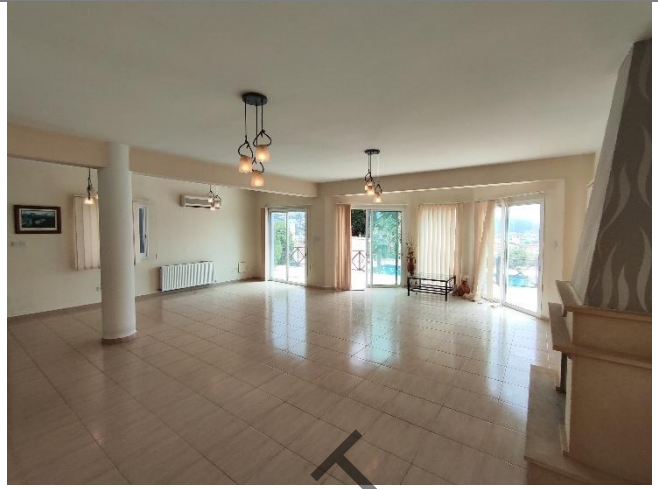
P2: Internal walls were found in sound condition.

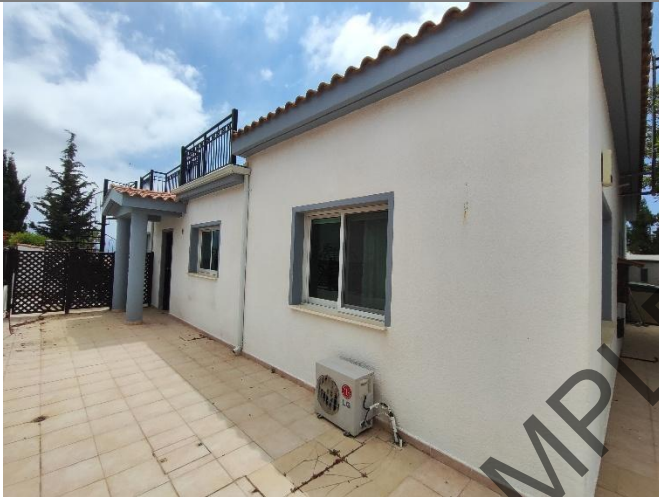
P3: External walls were found in sound condition.

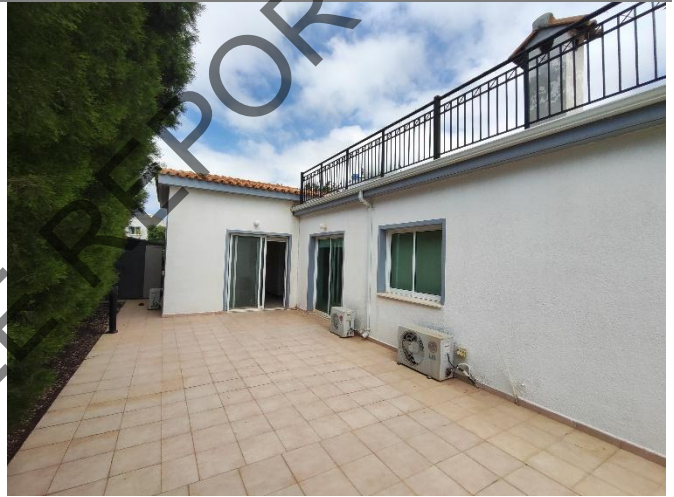
P4: External walls were found in sound condition.

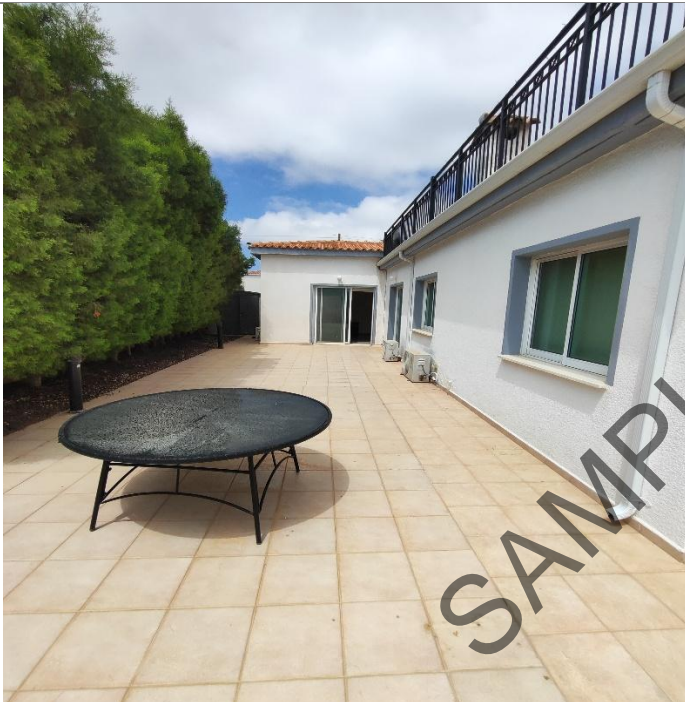
P1- General weathering and deterioration of external ceramic tiled finishes noted to various external areas consistent with age and external exposure.

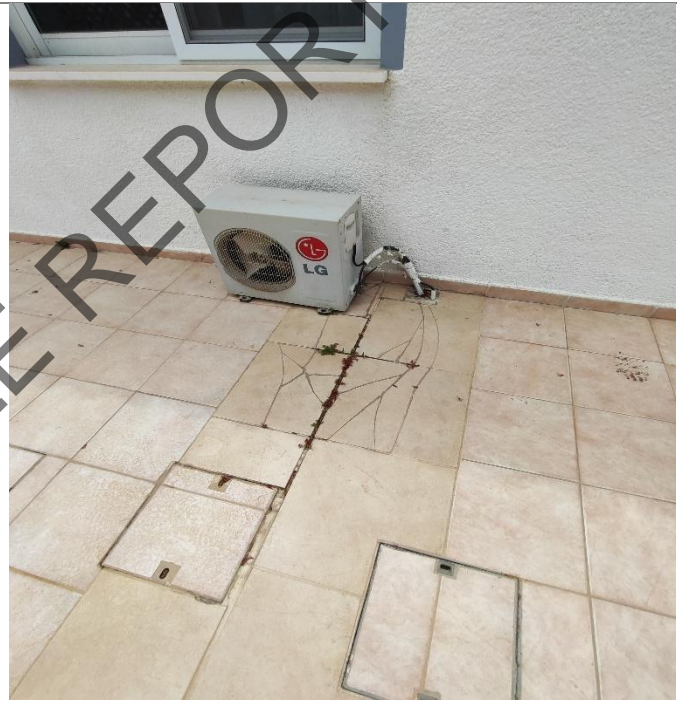
P2: Localized cracked tiled sections and minor deterioration to grout joints were also observed in isolated areas.

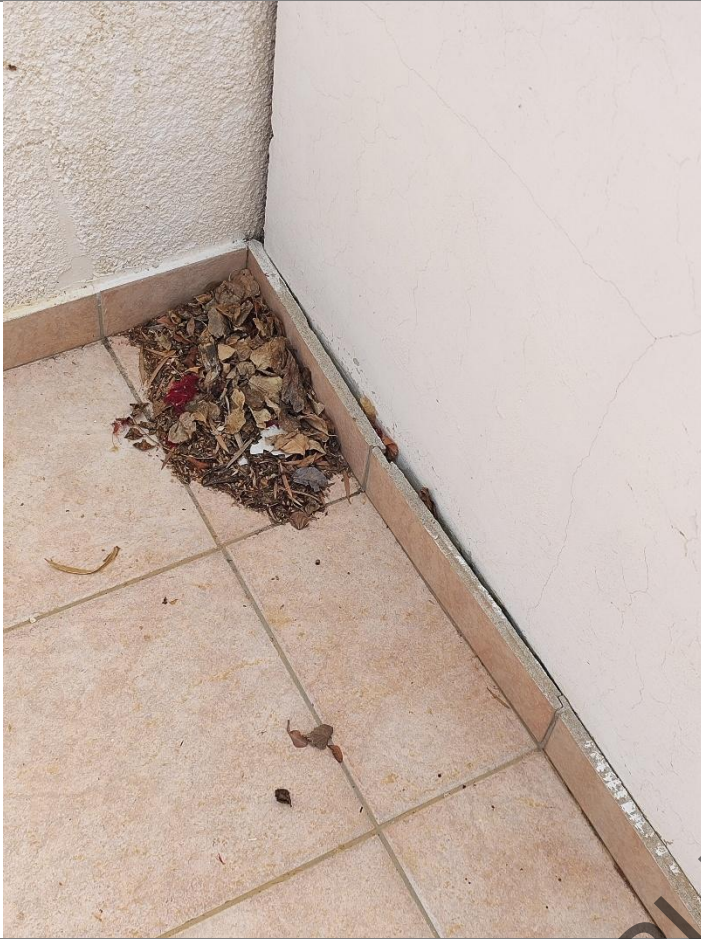
P3: Localized cracked tiled sections and minor deterioration to grout joints were also observed in isolated areas.

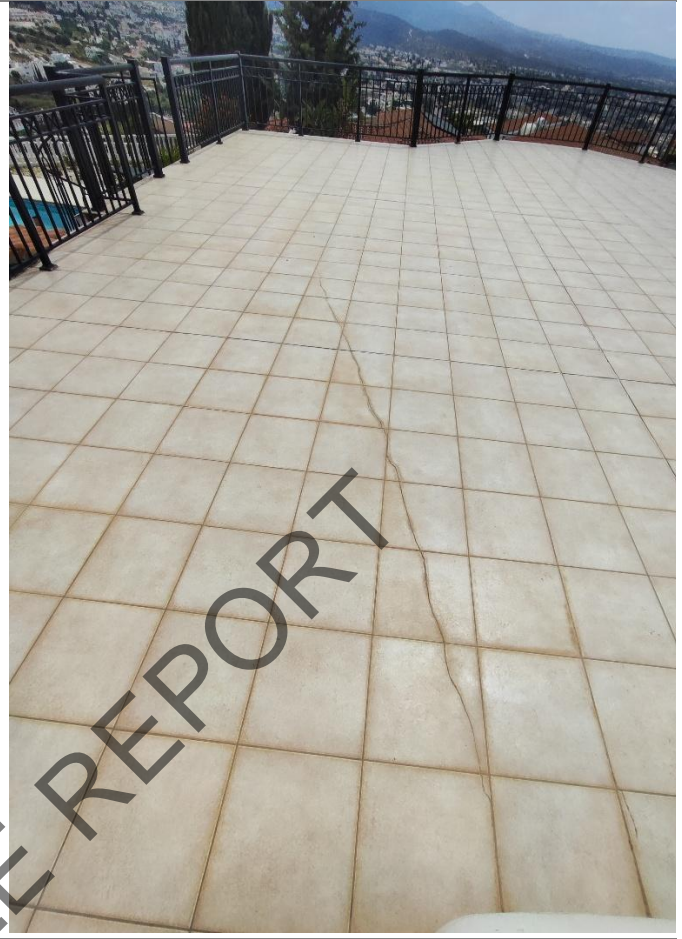
P4: Long continuous crack observed extending through multiple tiled sections across the roof garden tiled surface, including localized opening of grout joints.

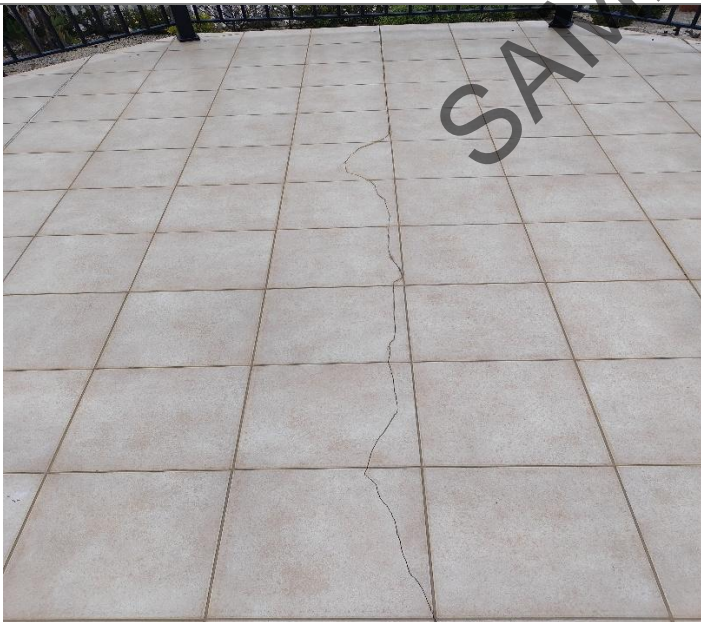
P5: Long continuous crack observed extending through multiple tiled sections across the roof garden tiled surface, including localized opening of grout joints.

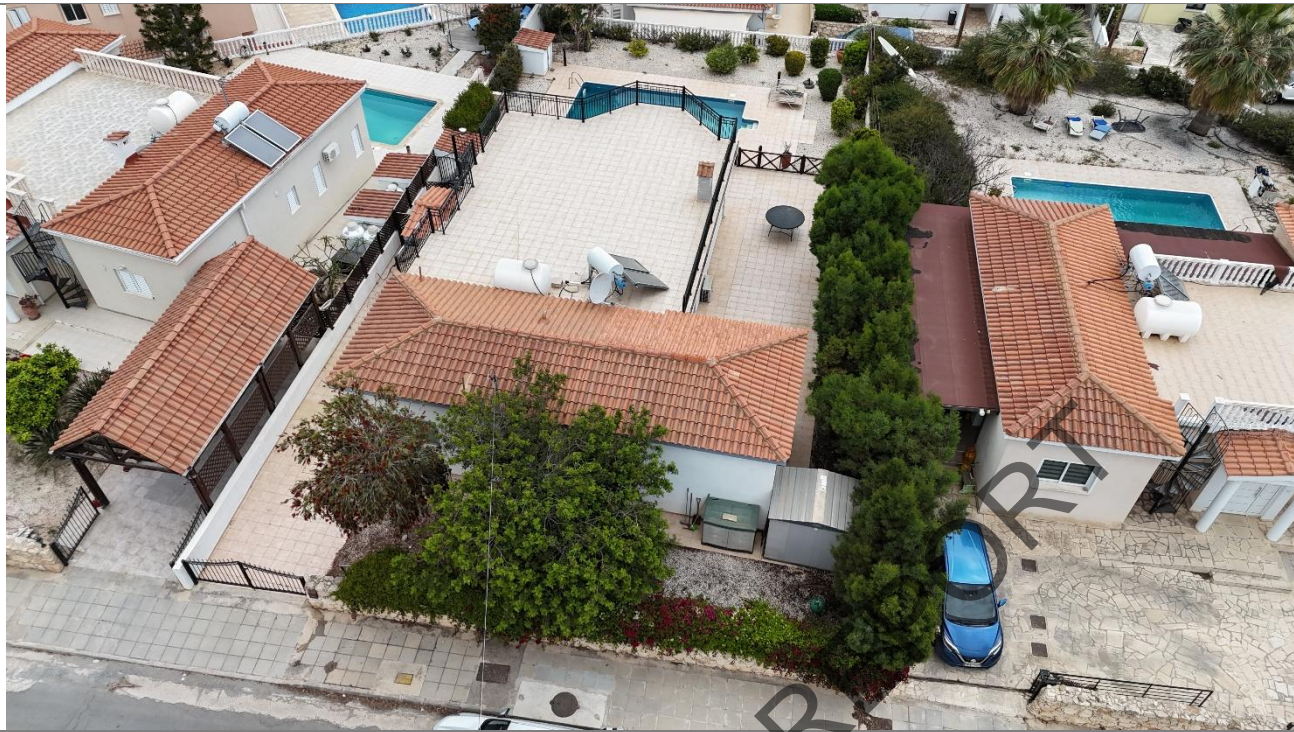
P1: The roof of the property was found in sound condition.

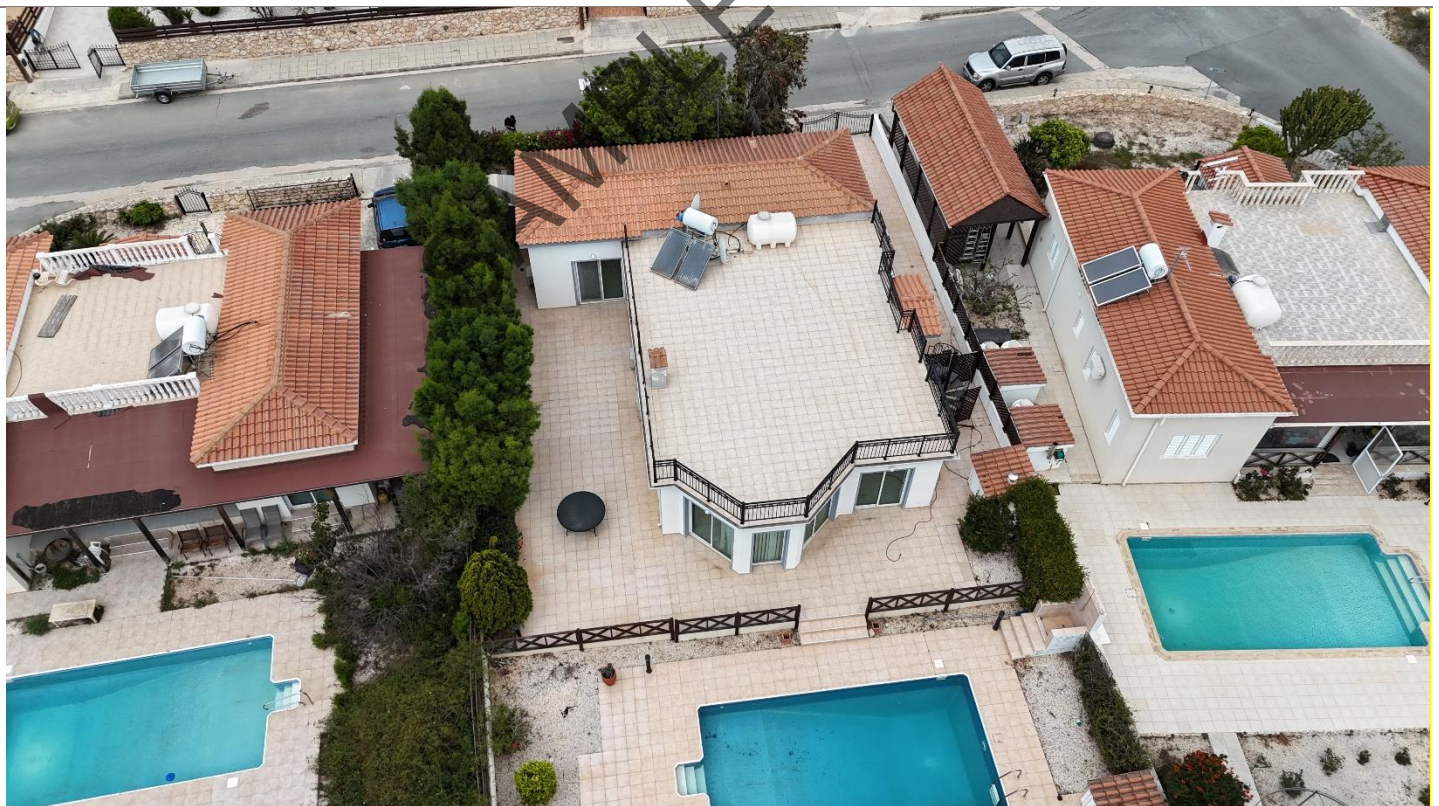
P2: Debris accumulation noted within sections of the perimeter rainwater gutters/drainage channels serving the roof garden area.

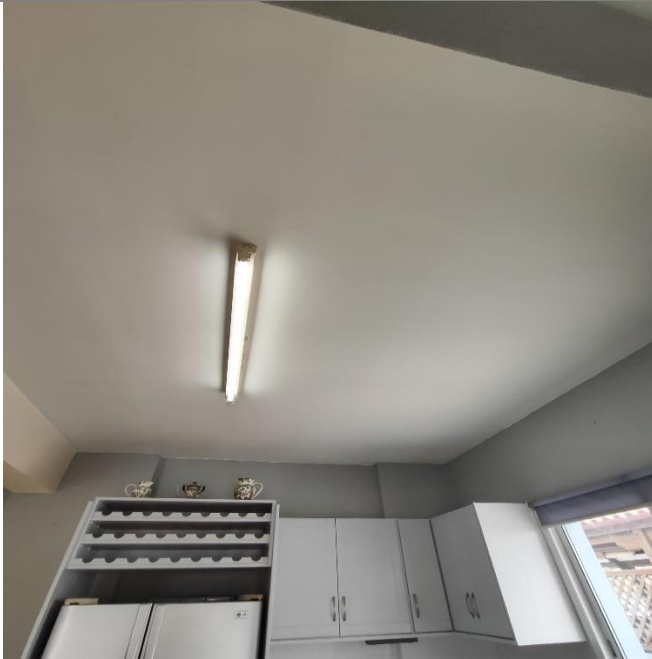
P1- The internal ceilings were found in sound condition.

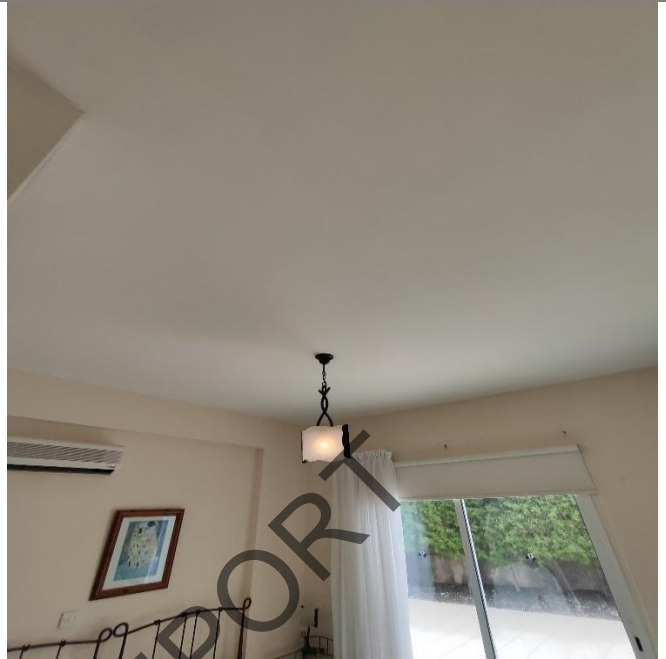
P2- The internal ceilings were found in sound condition.

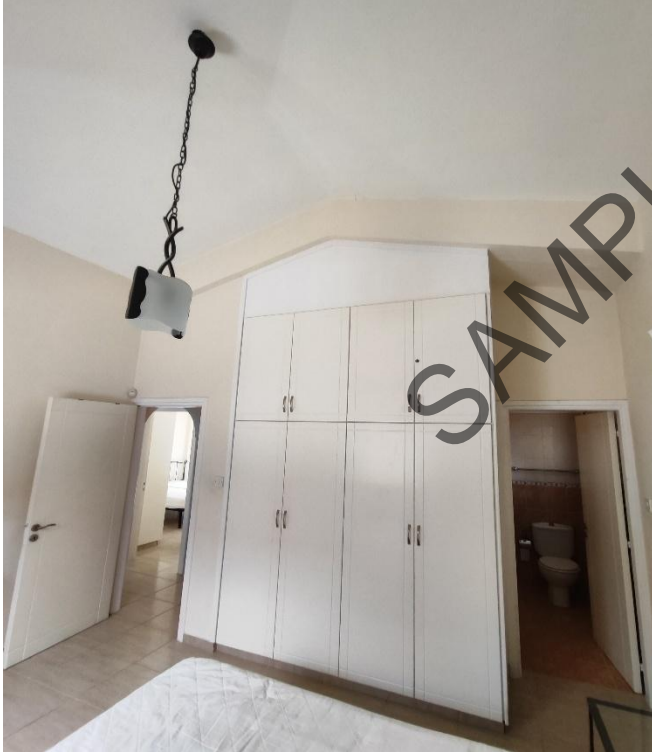
P3- The internal ceilings were found in sound condition.

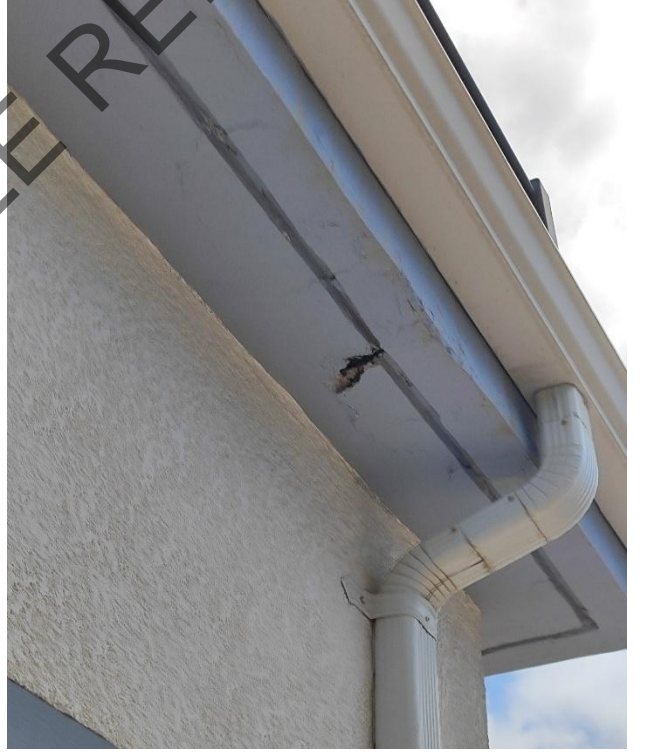
P4- Localised concrete spalling and deterioration noted to the external fascia/beam element beneath the roof overhang, with exposed and potentially corroded reinforcement visible.

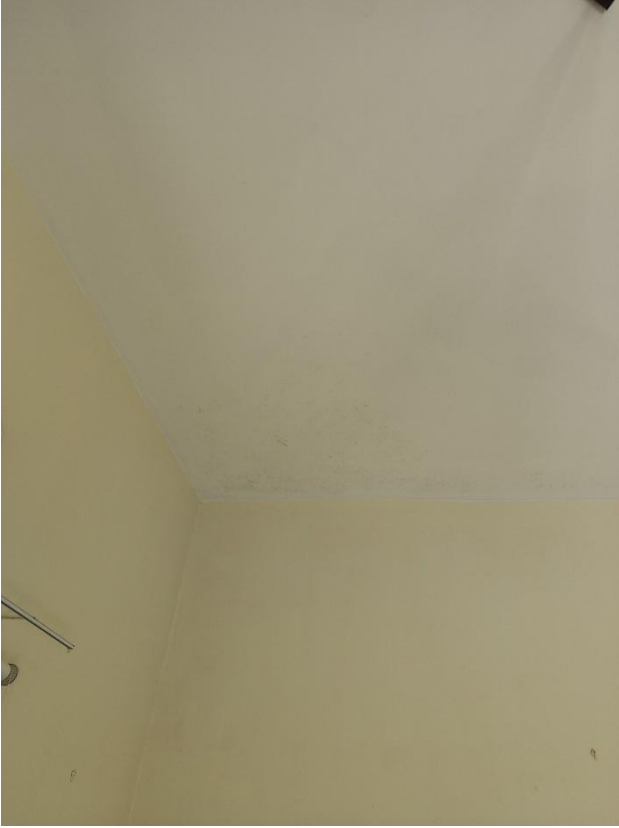
P5: Signs of localised mould formation were noted to the ceiling area within one of the bedrooms, potentially associated with condensation.

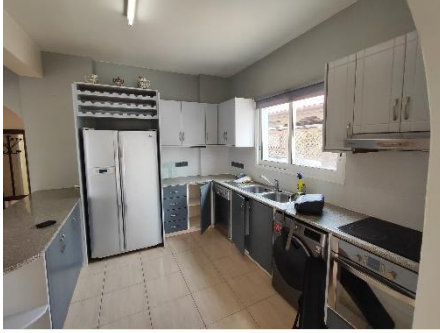
P1: Sanitary ware were found in sound condition.

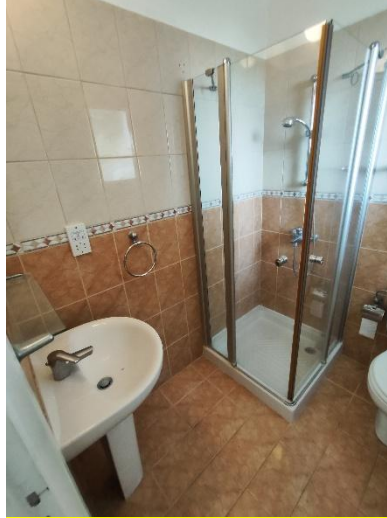
P2: Sanitary ware were found in sound condition.

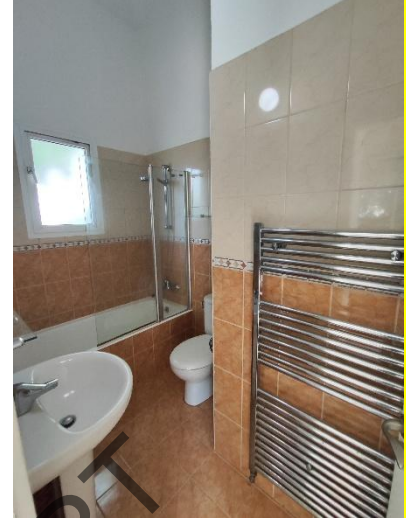
P3: Sanitary ware were found in sound condition.

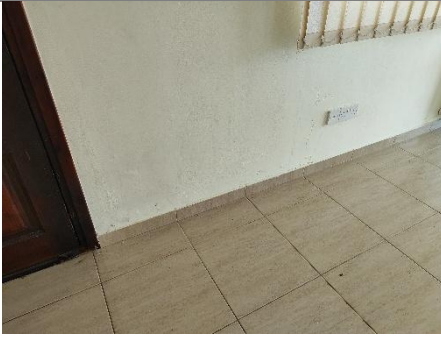
P1: Localized signs of possible rising damp/moisture-related deterioration noted to lower sections of the internal side of external perimeter walls

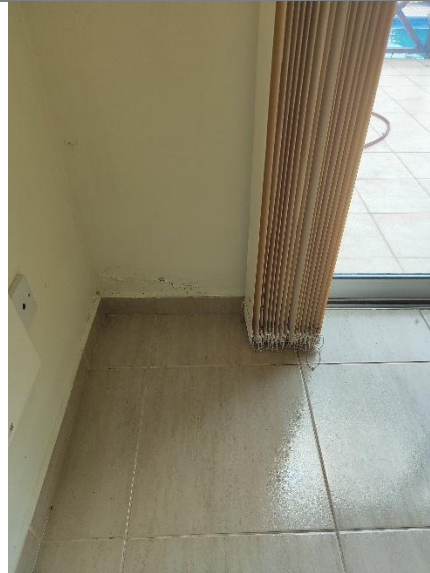
P2: Localized signs of possible rising damp/moisture-related deterioration noted to lower sections of the internal side of external perimeter walls

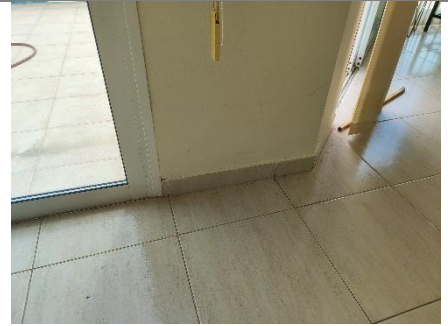
P3: Localized signs of possible rising damp/moisture-related deterioration noted to lower sections of the internal side of external perimeter walls

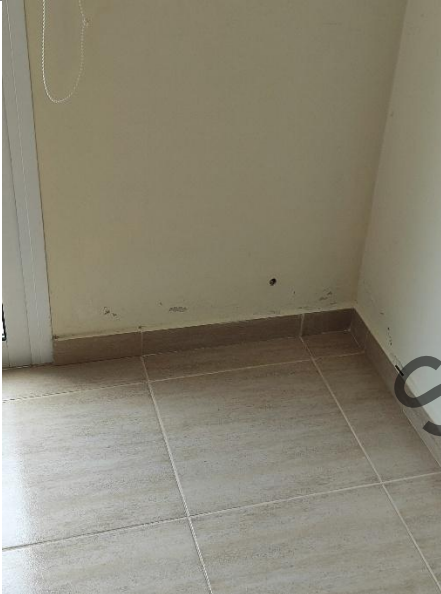
P4: Localized signs of possible rising damp/moisture-related deterioration noted to lower sections of the internal side of external perimeter walls

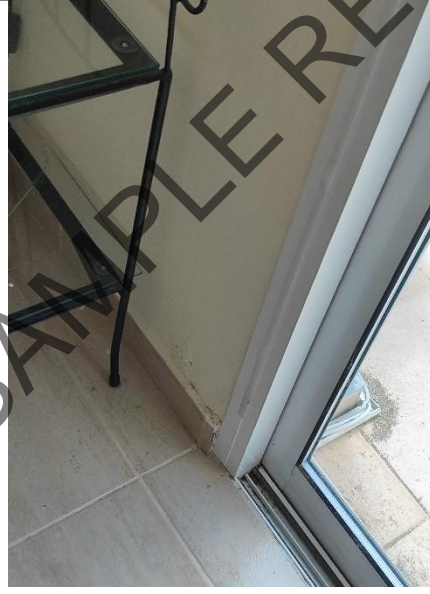
P5: Localized signs of possible rising damp/moisture-related deterioration noted to lower sections of the internal side of external perimeter walls

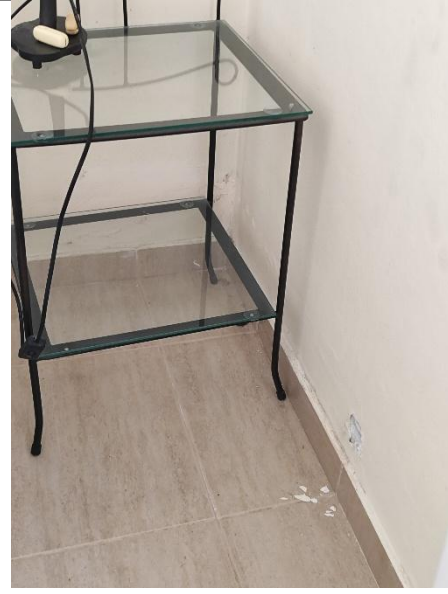
P6: Localized signs of possible rising damp/moisture-related deterioration noted to lower sections of the internal side of external perimeter walls

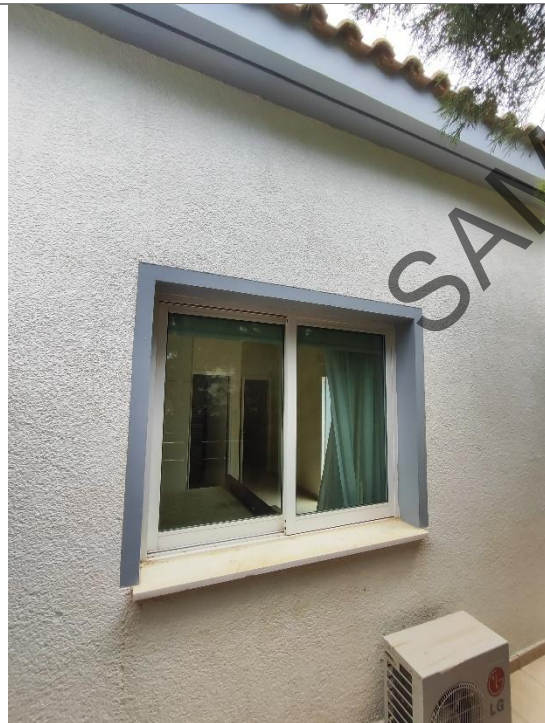
P1: Opening were found in sound condition.

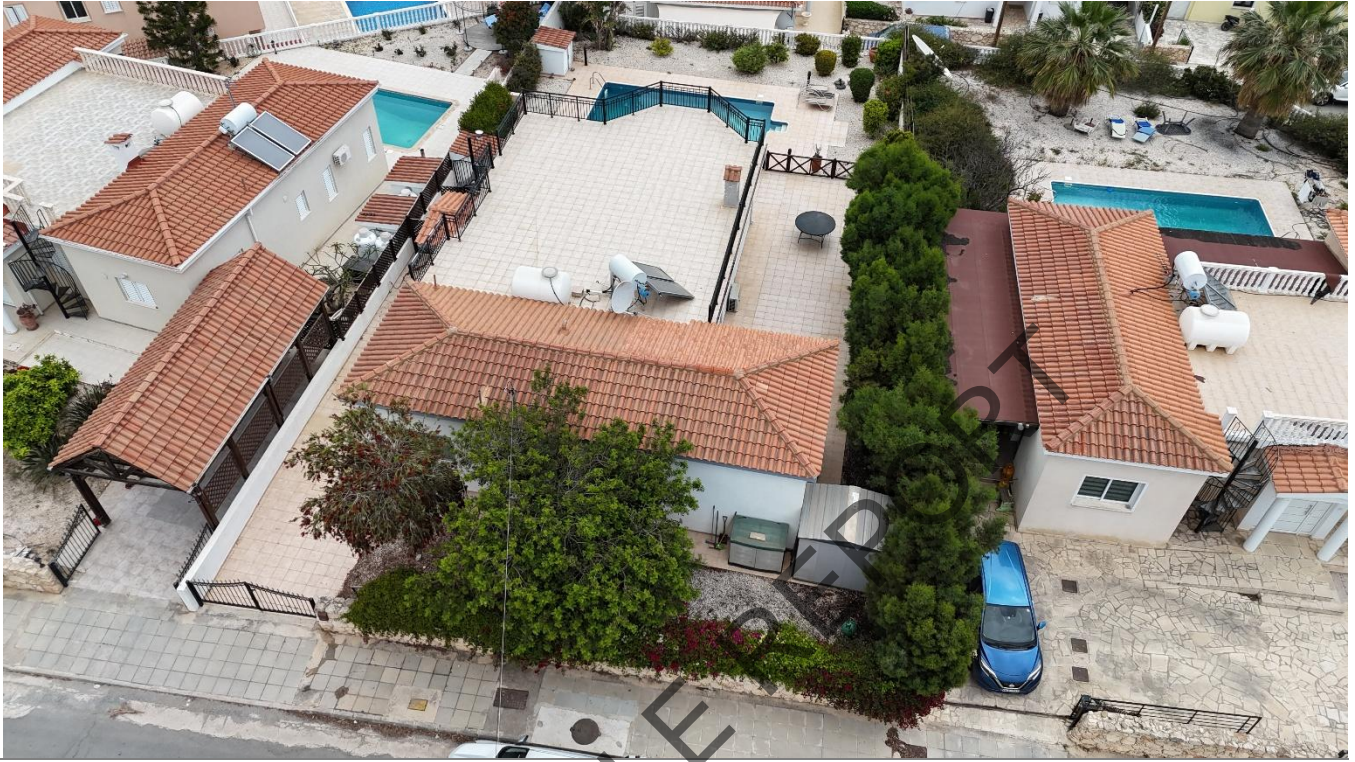
P1: External areas of the property at the time of the inspection.

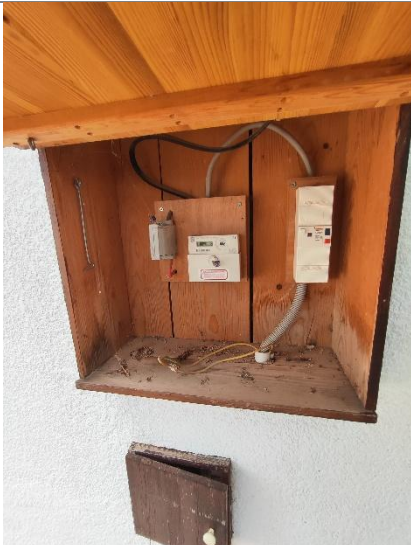
P1: The electrical meter of the property.

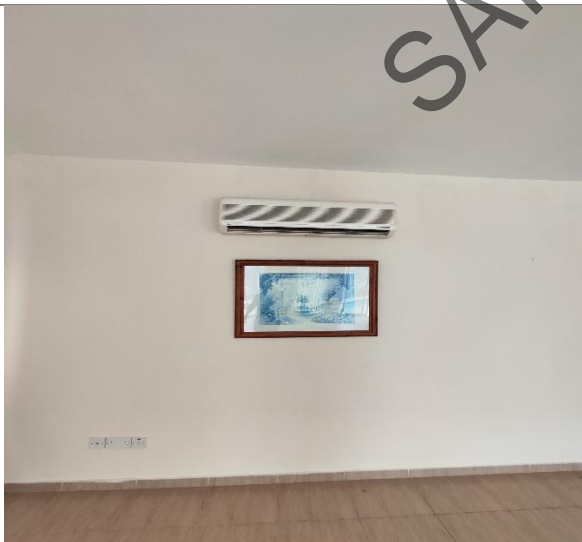
P1: Ac unit installation within the property.

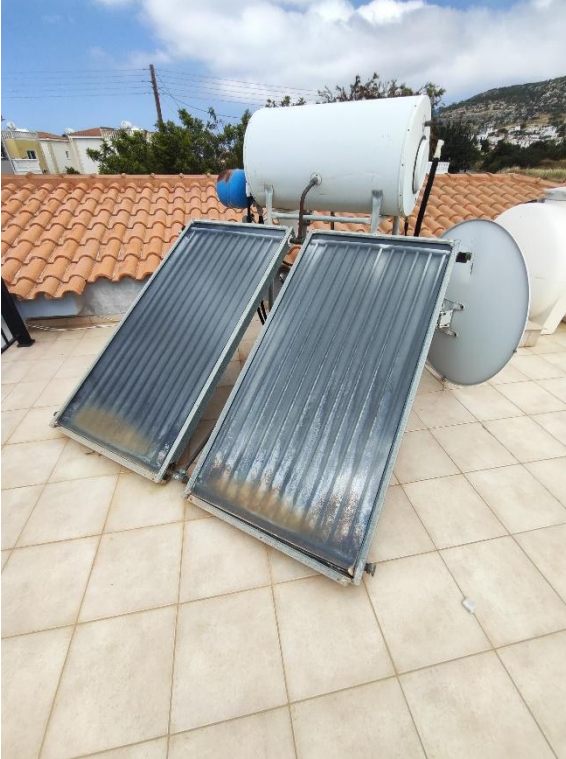
P1: Localized weathering, surface corrosion, and general aging noted to sections of the solar water heating installation and associated metal support frame/components at roof level consistent with prolonged external exposure conditions.

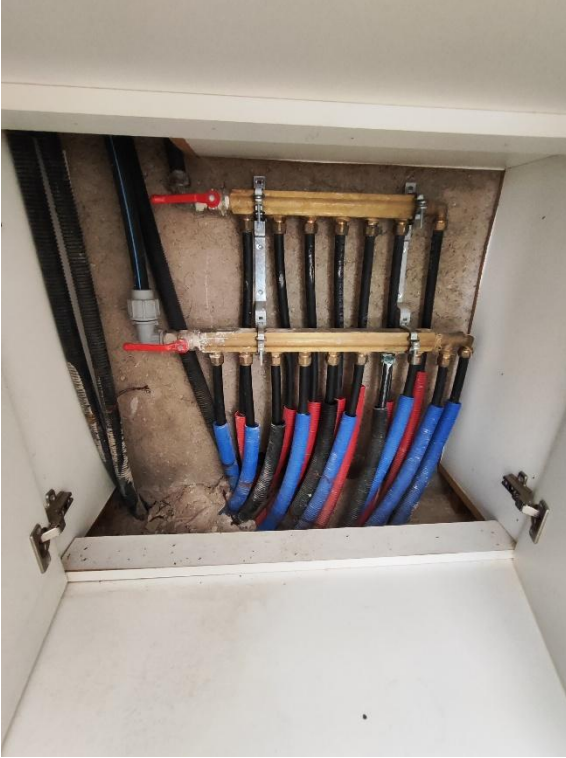
P1: Manifolds/distribution board

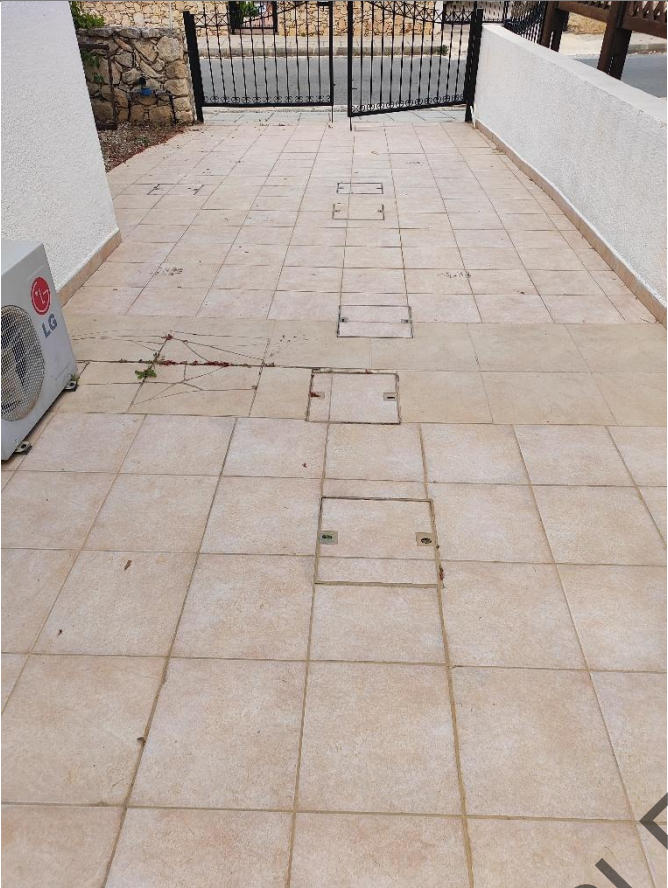
P1: Sewerage manholes around the property.

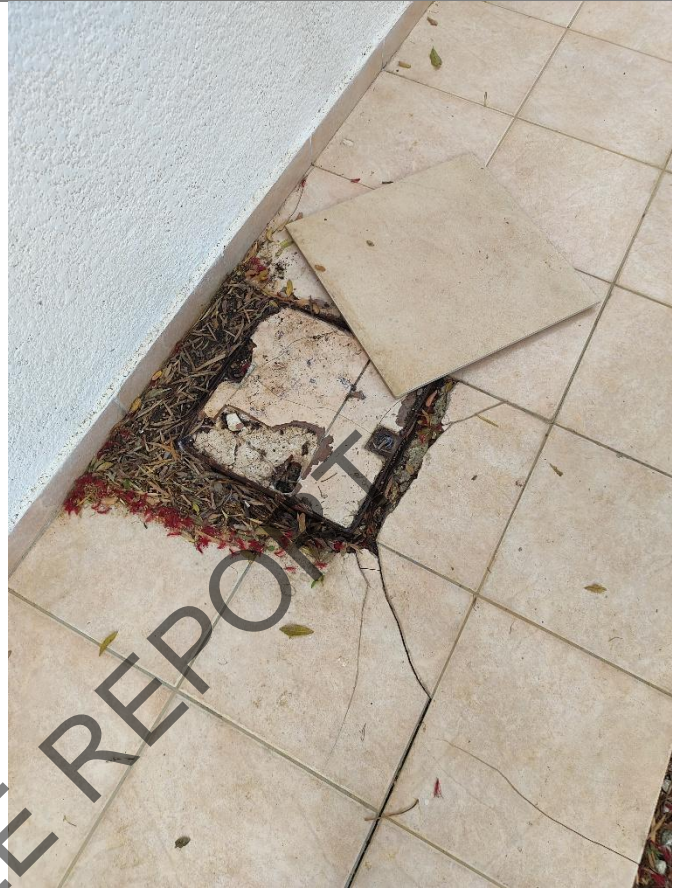
P2: Damage and deterioration noted to the external sewerage inspection chamber cover and surrounding tiled finishes, including cracked/broken cover sections and localized displacement/damage to adjacent tiles

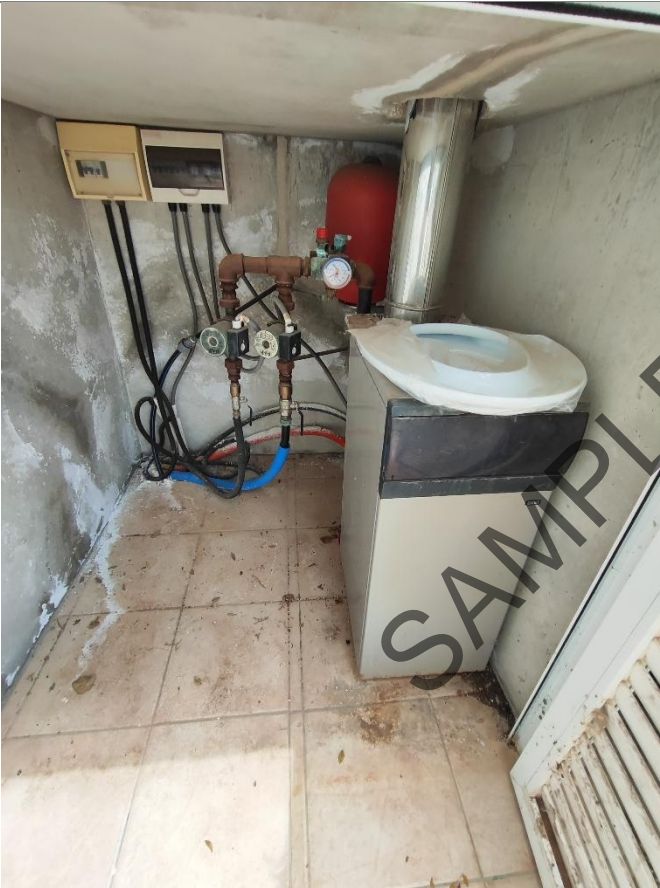
P1: Localized dampness, moisture staining, and deterioration to wall finishes were noted within the mechanical/plant room area, particularly at lower wall sections and around service penetrations.

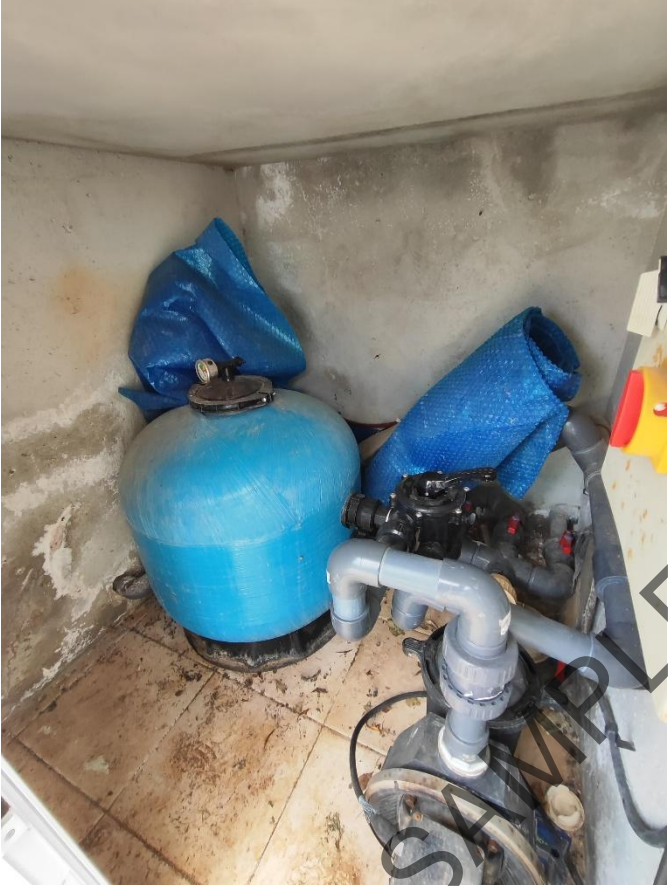
P1: Localized dampness, moisture staining, and deterioration to wall finishes were noted within the mechanical/plant room area, particularly at lower wall sections and around service penetrations.

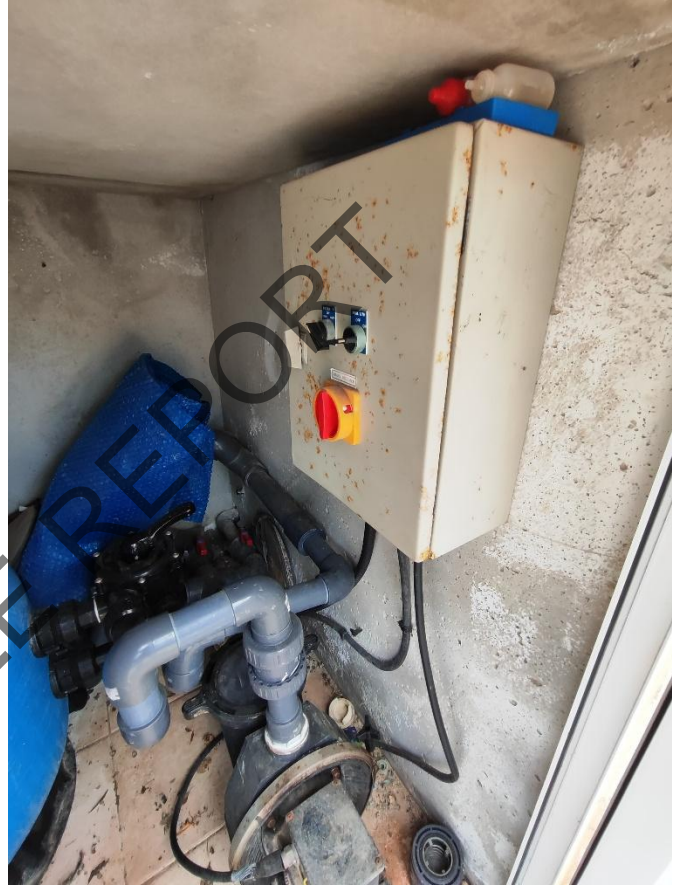
P2: Minor corrosion and weathering were also noted to sections of the electrical control cabinet and associated components.
